"LANDSLIDE INVESTIGATIONS, MAIN NORTH LINE RAILWAY,
SOUTH ISLAND, NEW ZEALAND"

A thesis
submitted in partial fulfilment
of the requirements for the degree
of
Master of Science in Engineering Geology
in the
University of Canterbury

G. Guy Grocott, BSc, BSc (Hons.)

May, 1977

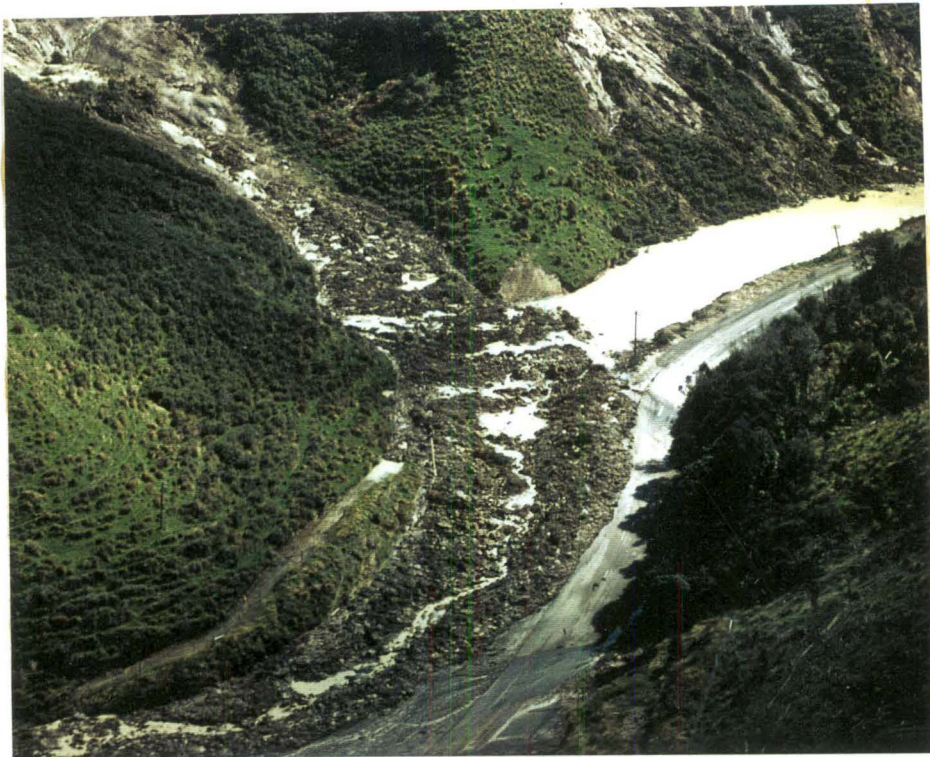
Frontispiece. The effect of slope instability on communication routes: storm damage following the passage of Cyclone Alison over the steep coastal Kaikoura district, South Island of New Zealand (March, 1975).

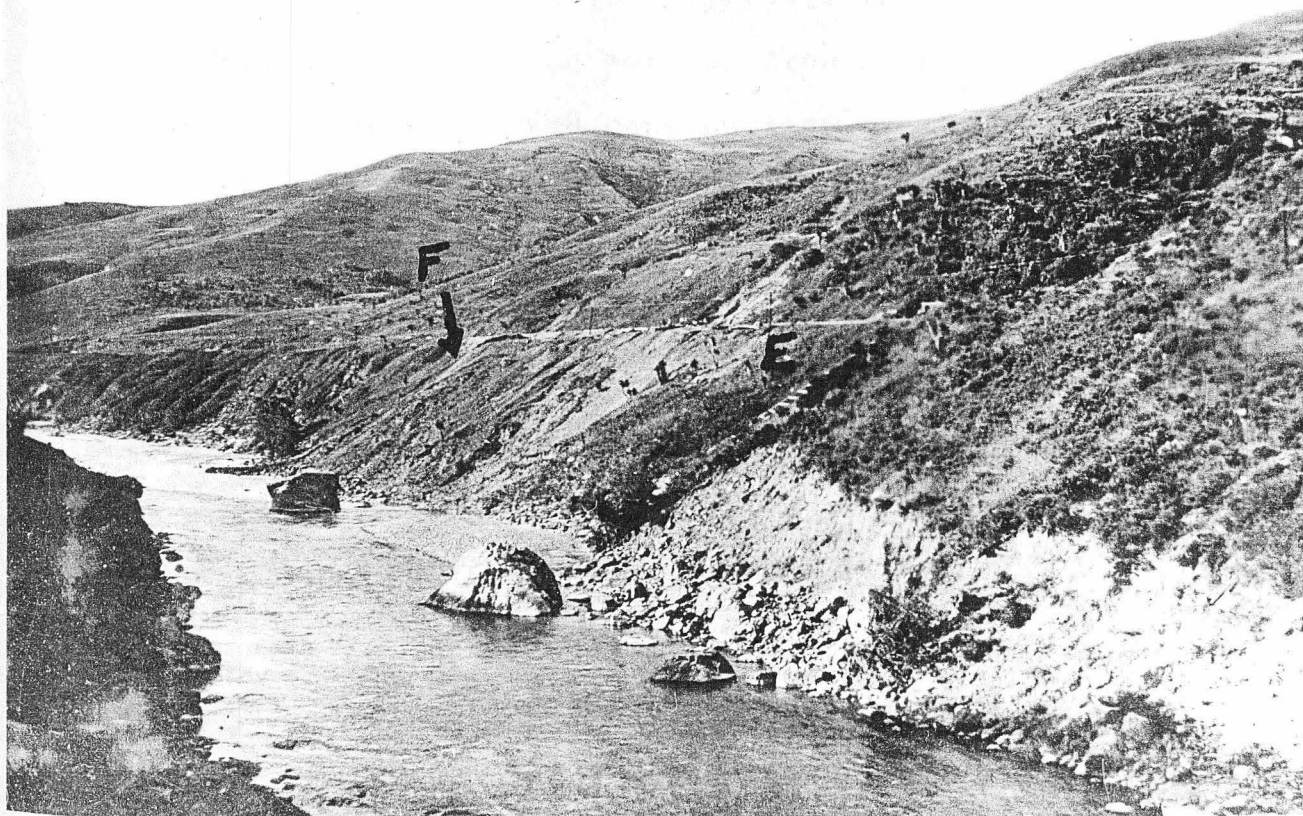
PLATE 5

Plate 5. Looking up the Hurunui River in 1923.

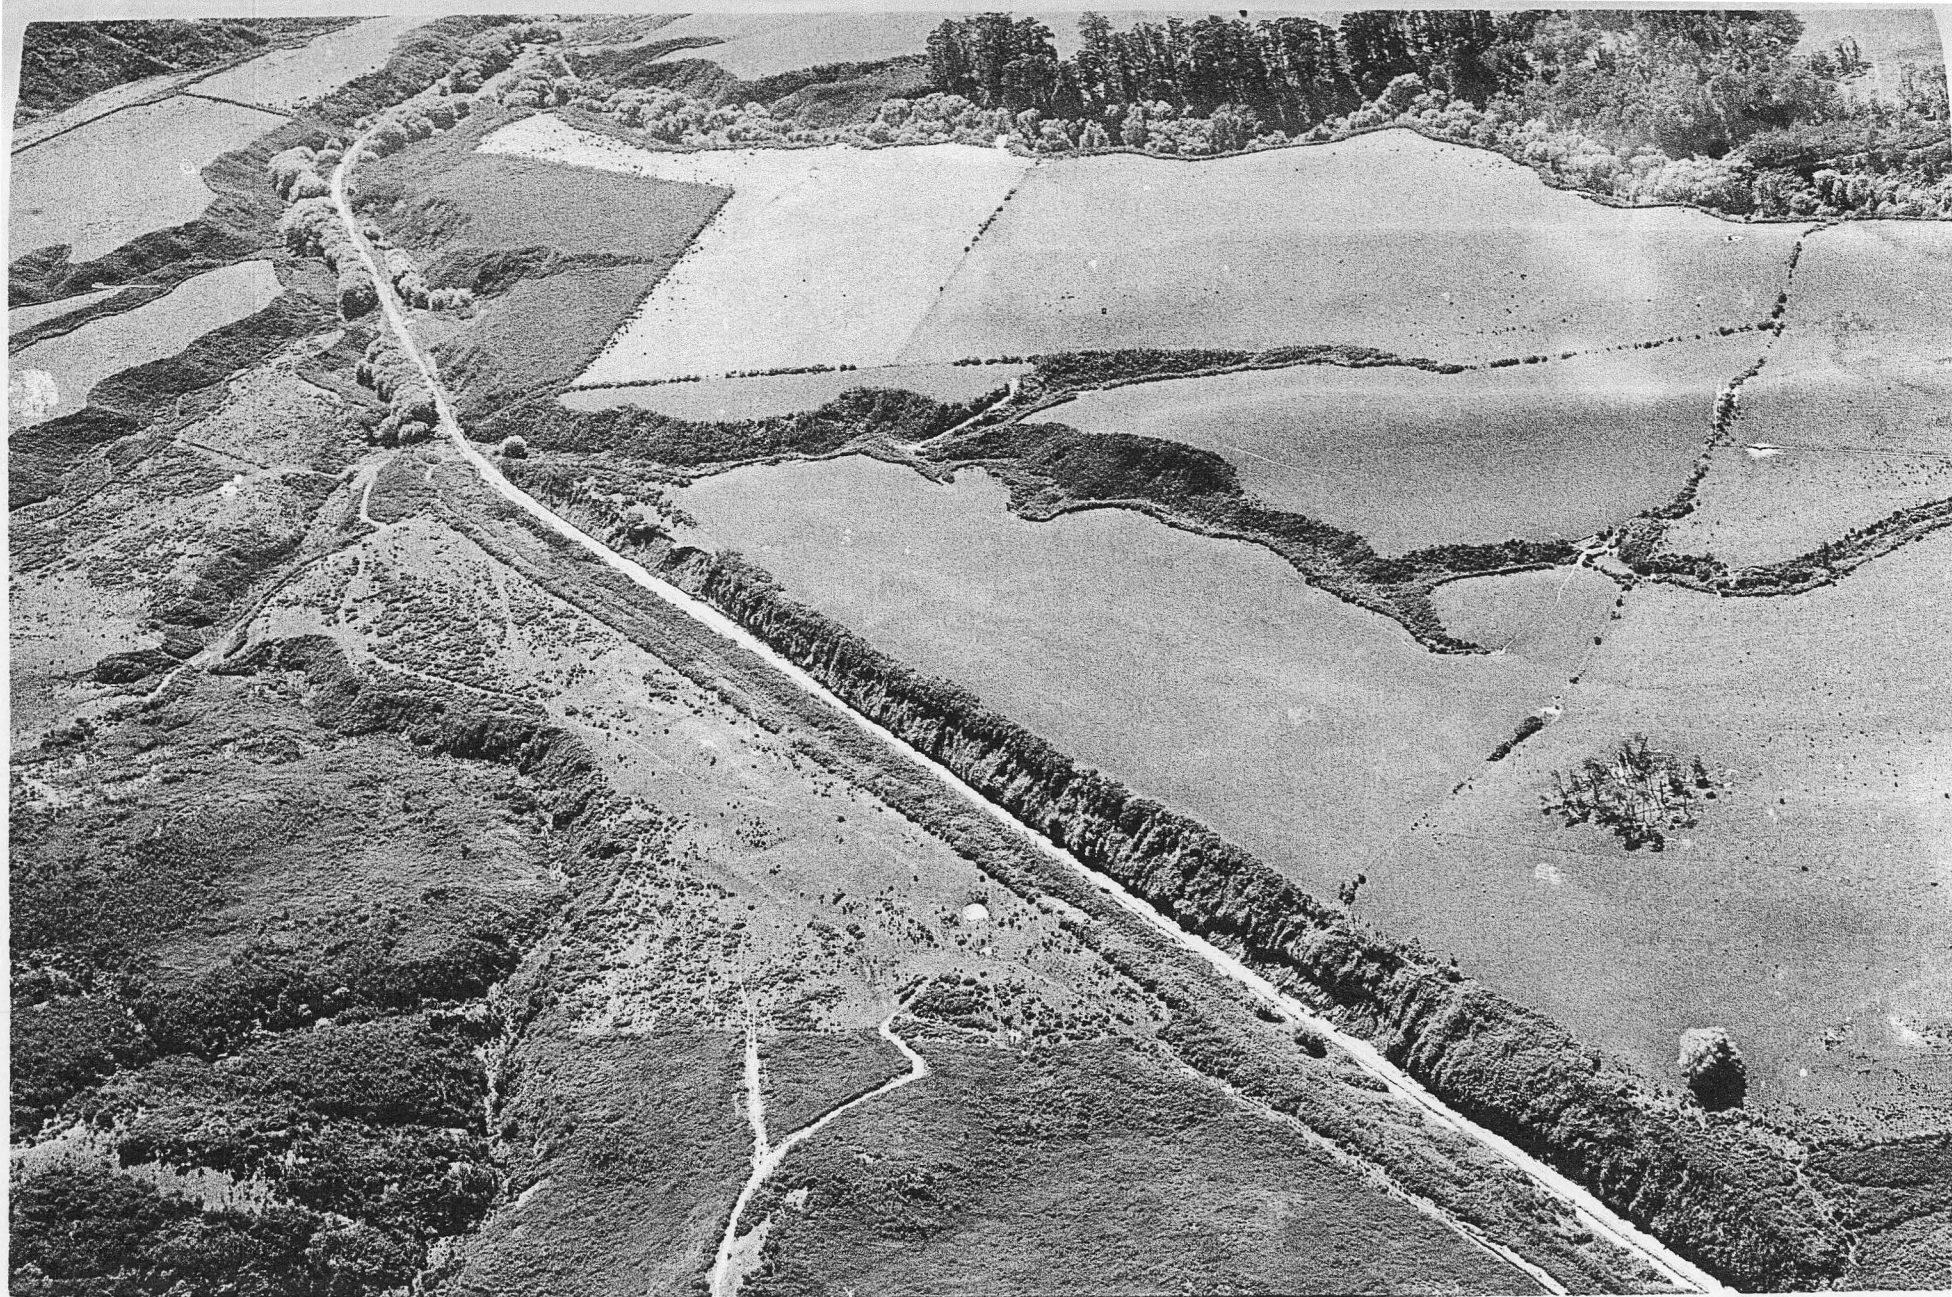
PLATE 6. The Hawkswood Cut.

The earliest recorded slip occurred several weeks after completion of the excavation in 1937, delaying track laying for several days. During heavy rain in March and August, 1941 slips totalling 760 and 600 cu. m, respectively,

caused delays to rail traffic, for eight days in the first instance, and covered the line to a depth of 1 metre in the second. Two slips in September and October, 1943 totalling 1100 cu. m caused a combined delay to traffic of four days. Heavy rain in February, 1945 caused several 300 cu. m slips of the order of 12m long by 2m deep, and 37m long by 0.75m deep, while in August of the same year the line was blocked by slips for three days. In August, 1961 a large slip of approximately 6000 cu. m filled the cutting after torrential rain. More recently 1100 cu. m of spoil were removed during 1975.

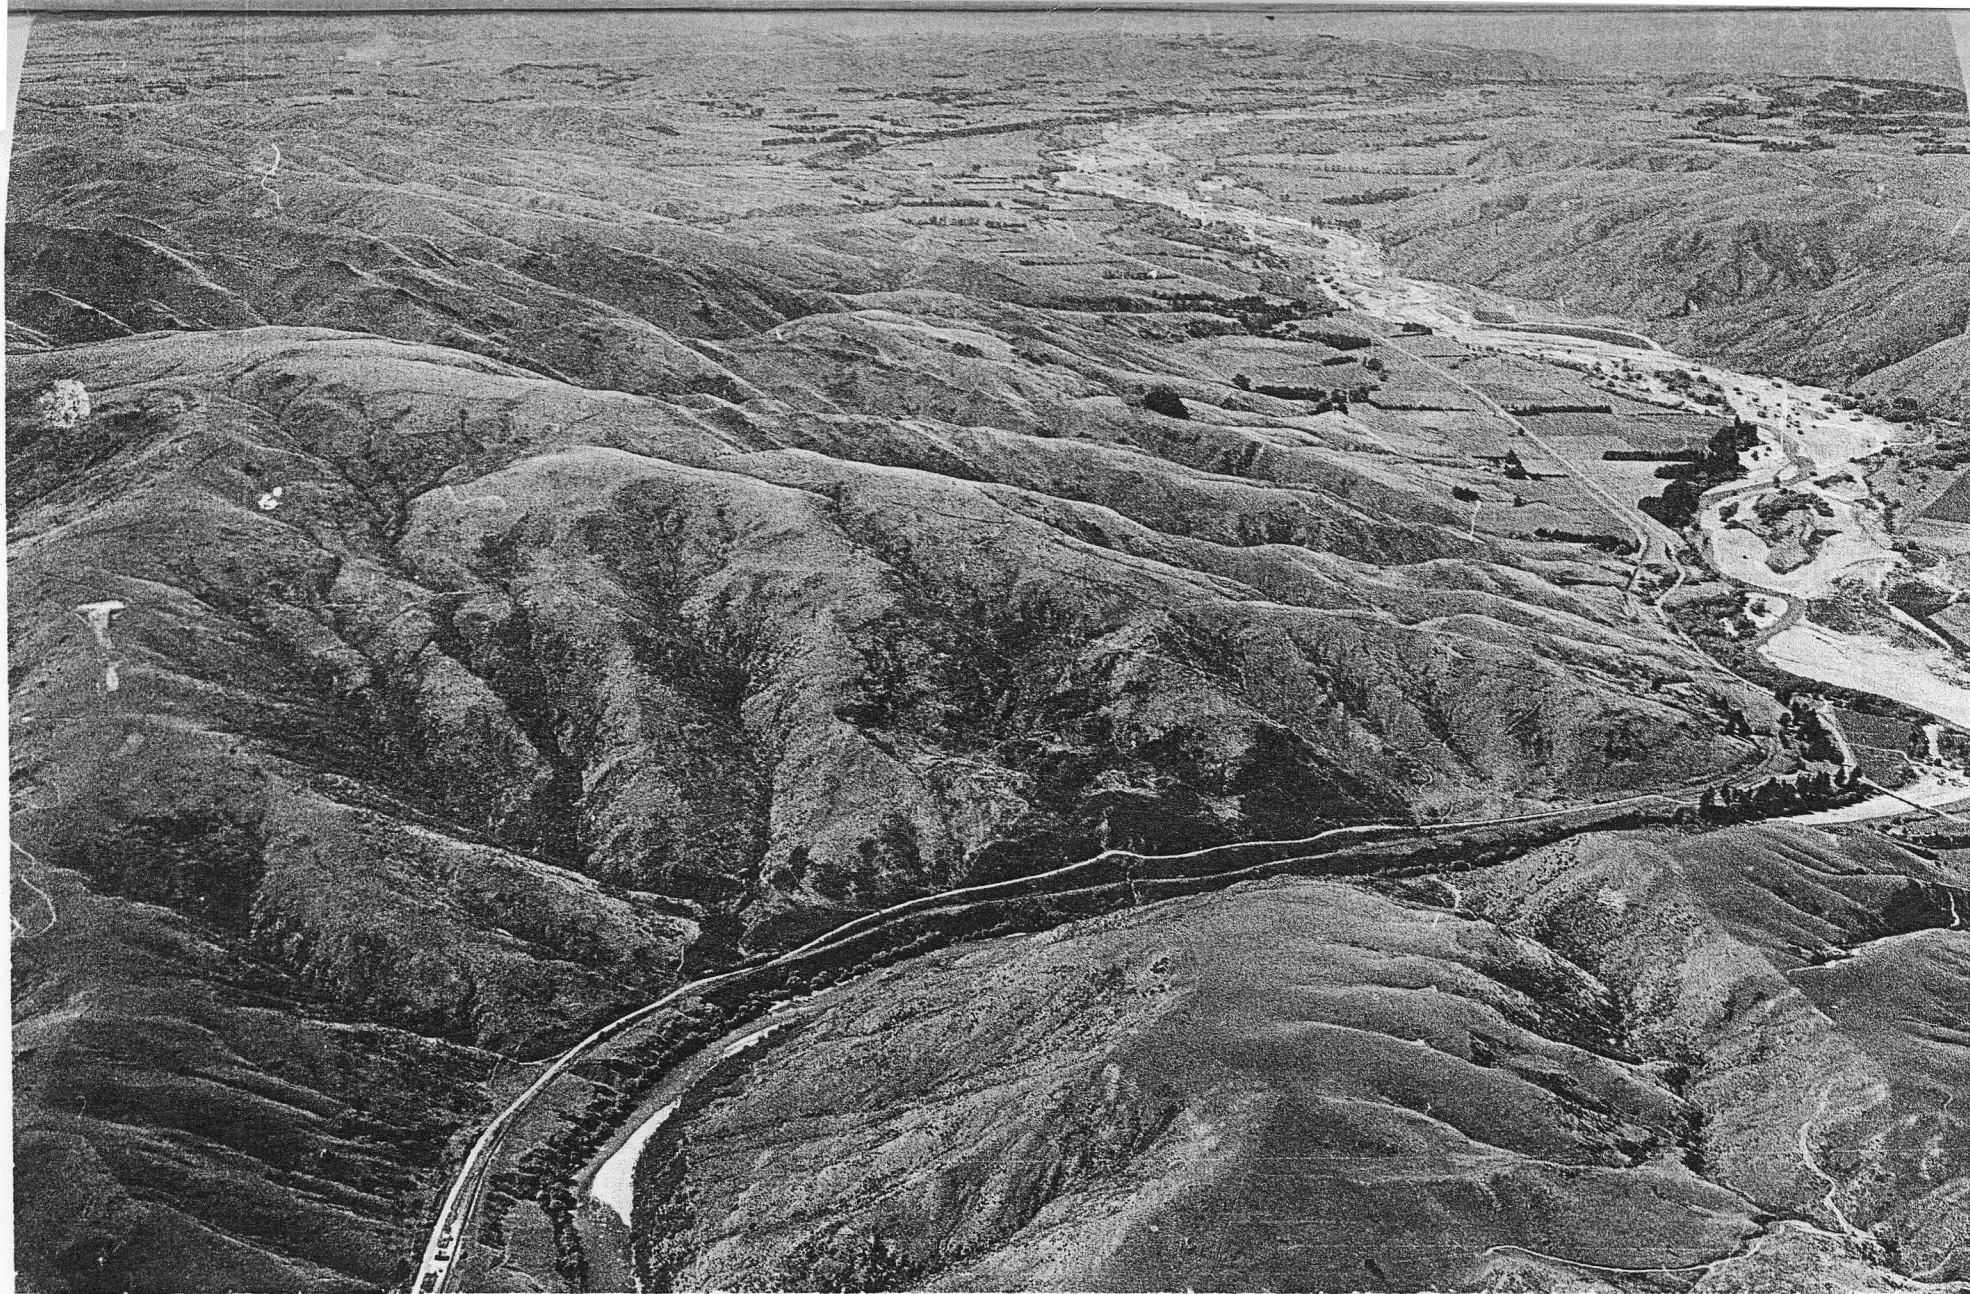
PLATE 8. The Ethelton Slip. The landslide occupies the basin-like feature in the centre of photograph. The Main North Line and the Cheviot County Council road are clearly seen at the foot of the landslide.

taken. This consisted of a study of Railways Department files dating back to 1907. Several 1923 photographs of the landslide were also located (Plates 1-5). Results of this documentation review show the slide has a history of continuing downward and outward, intermittent movement. Displacement of the railway towards the Hurunui River accompanied this movement.

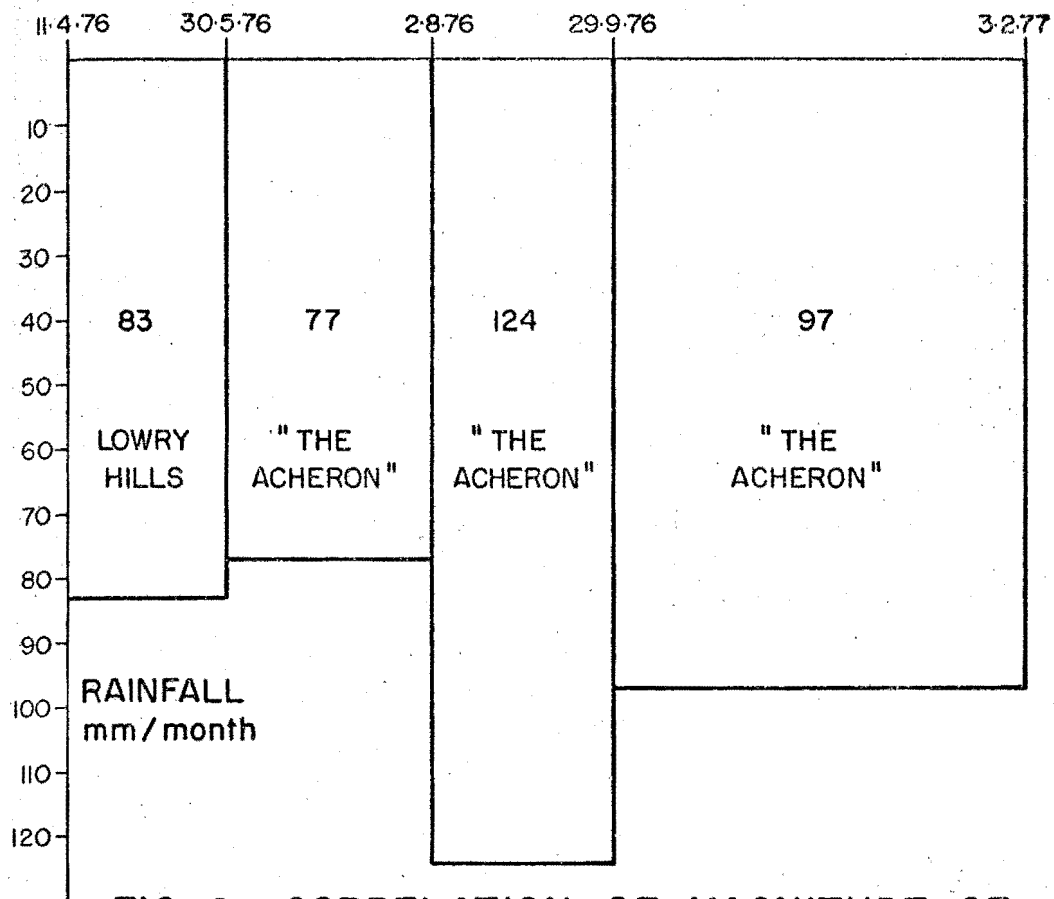
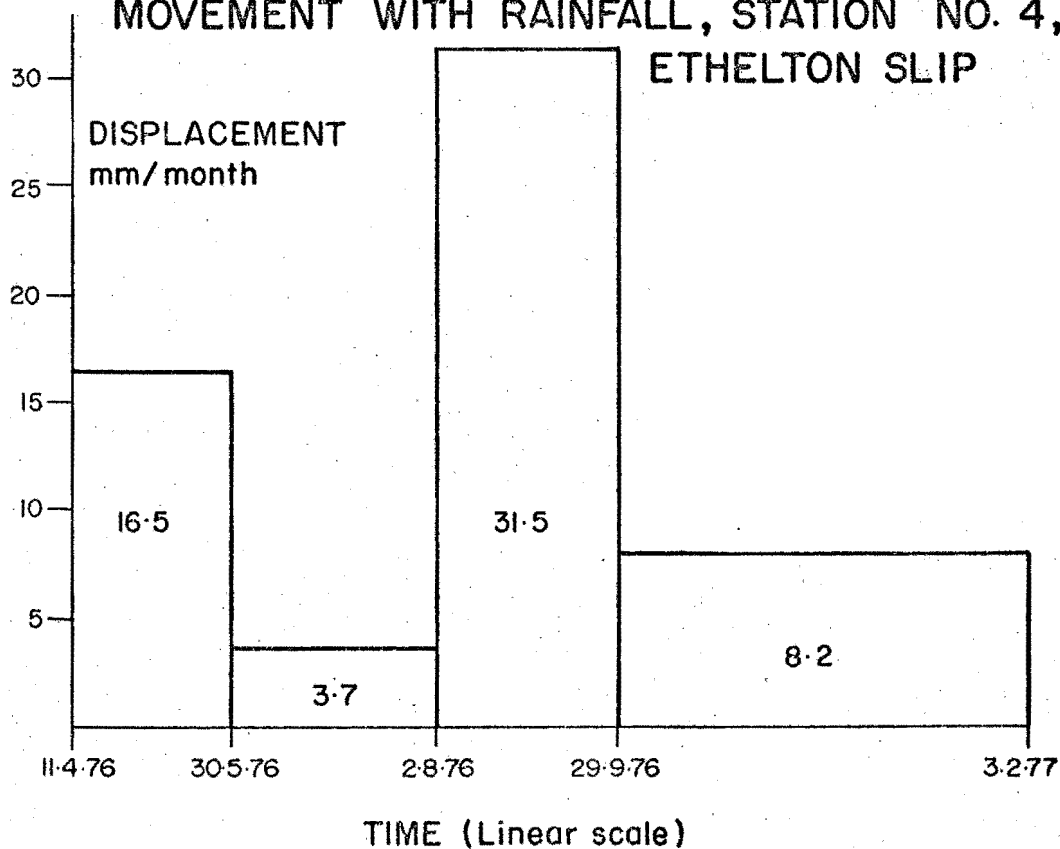
FIG. 9. CORRELATION OF MAGNITUDE OF MOVEMENT WITH RAINFALL, STATION NO. 4, ETHELTON SLIP

(d) Figure 9 summarises an attempted correlation of rainfall with rates of movement for marker No. 4.

(f) Insufficient time yet exists to establish a minimum rate of precipitation above which rates of movement within the active zone can be expected to accelerate. However, Figure 9 does tentatively infer a value of 100mm per month of rainfall received at the site above which rates of movement can be expected to increase.

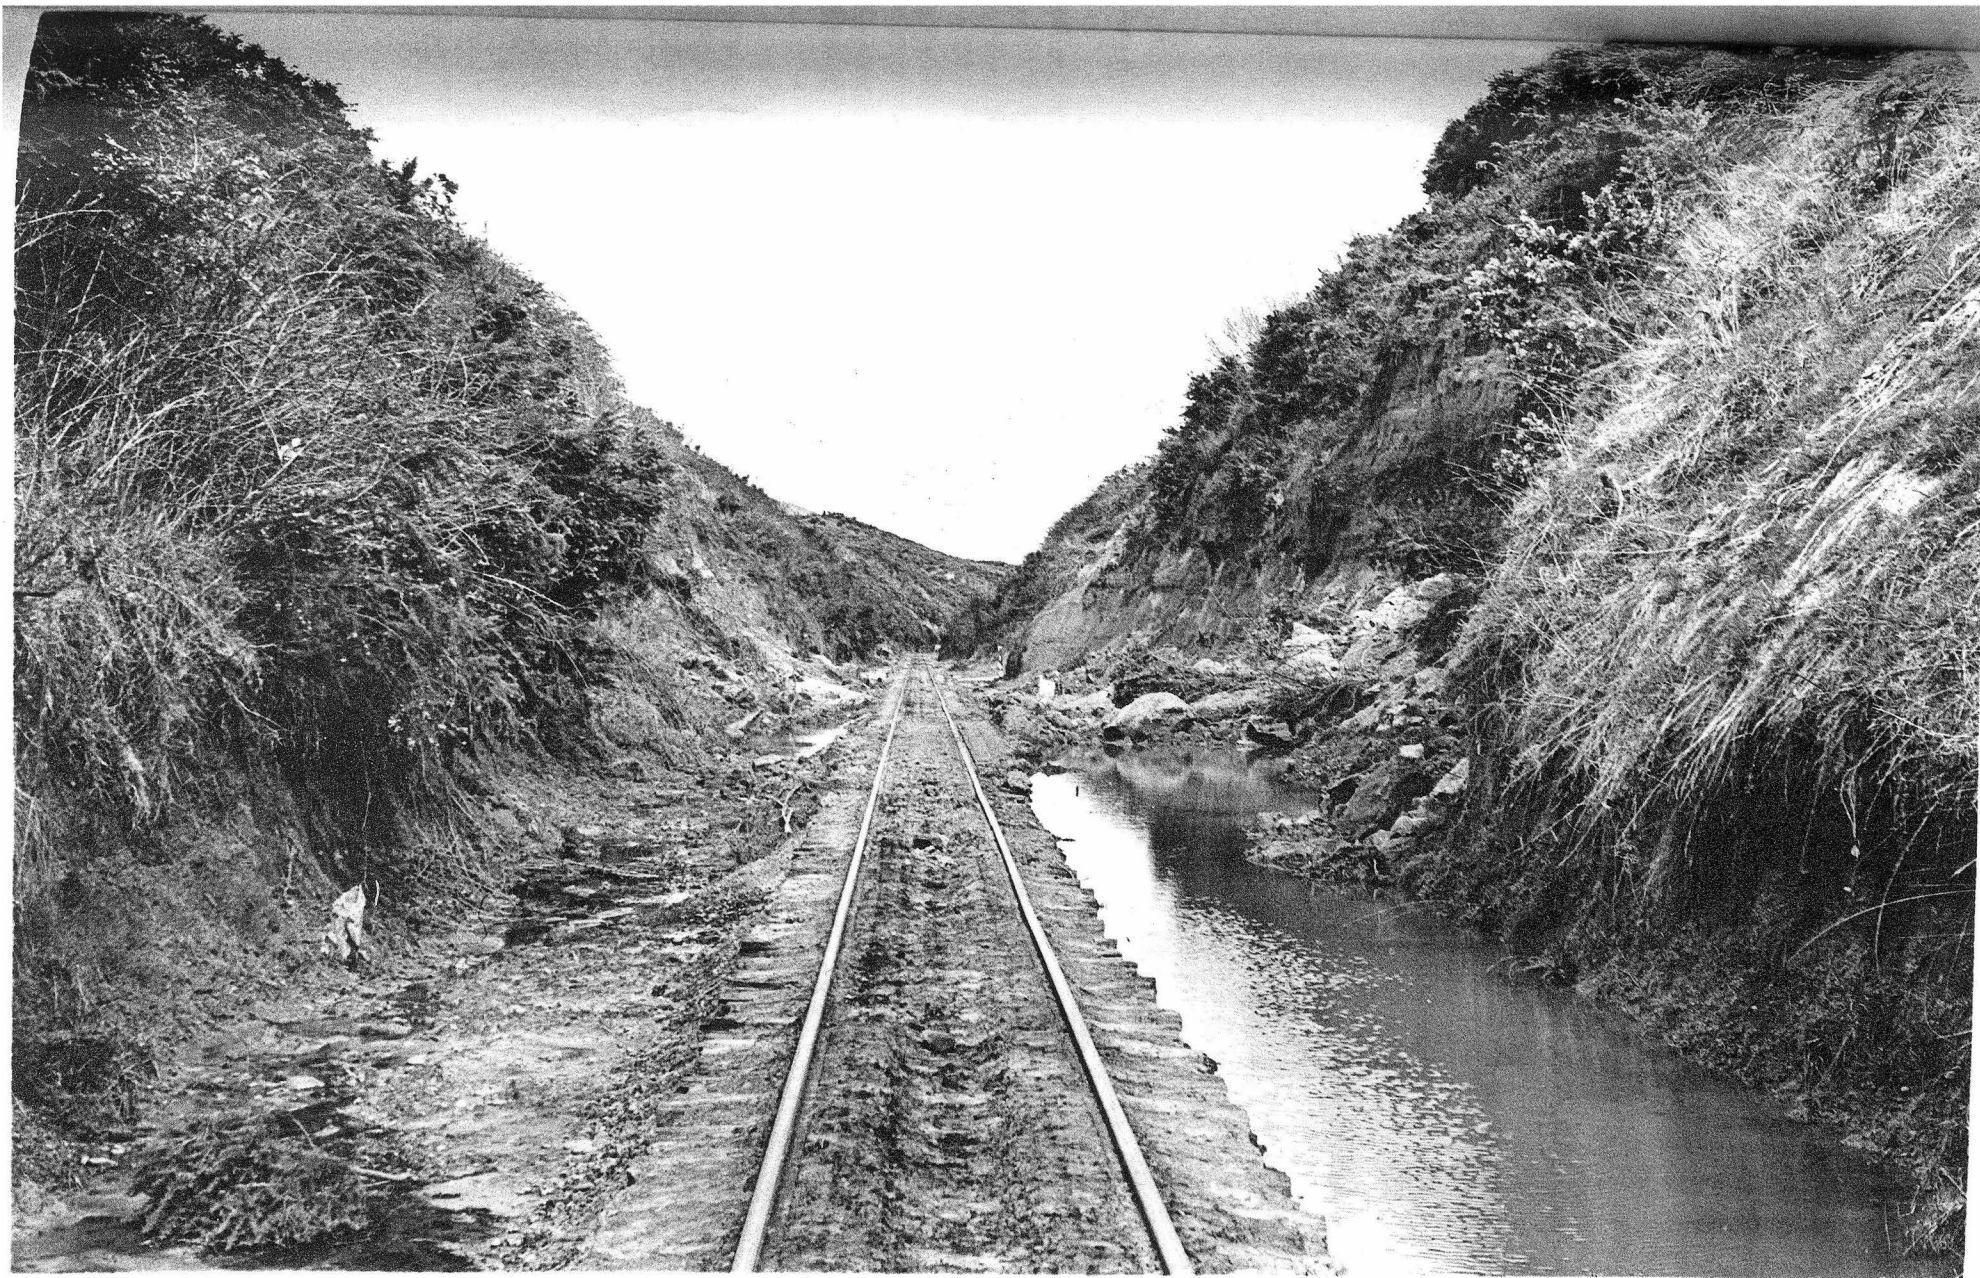
PLATE 11. The Hawkswood Cut. A view looking south.

long section has increased the batter here to a near-vertical angle. The Cut runs in a general north northwest direction (Fig. 13, Plate 11).

Two flumes, one running parallel with, the other down the eastern slope, and a 1m deep cutoff trench above the western crest, provide the only attempt at surface drainage. The cutoff trench was installed without levelling

however, and because of inadequate maintenance remains ponded along much of its course.

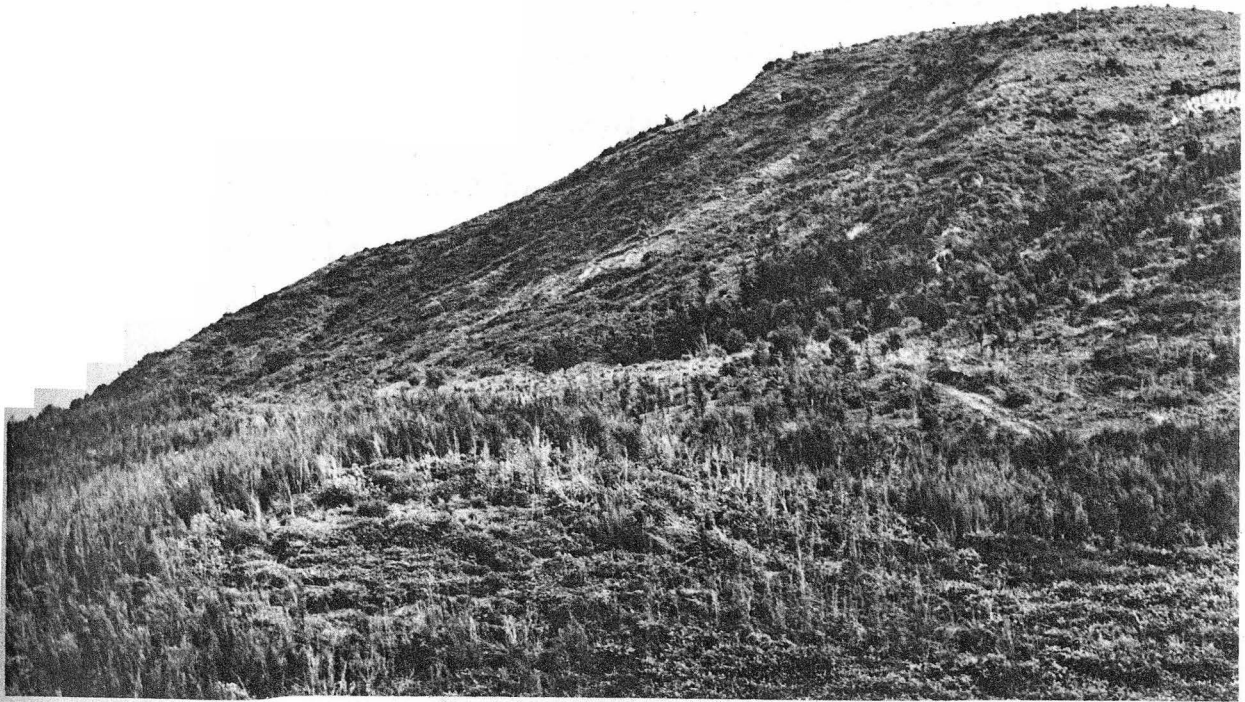
Uplift along the Hundalee Fault since the mid Pleistocene has been estimated at several hundred metres; recent movement along the fault is possibly illustrated by an inferred landslide immediately to the west of the Hawkswood Cut (Plate 13).

PLATE 13. An inferred landslide to the west of the Hawkswood Cut.

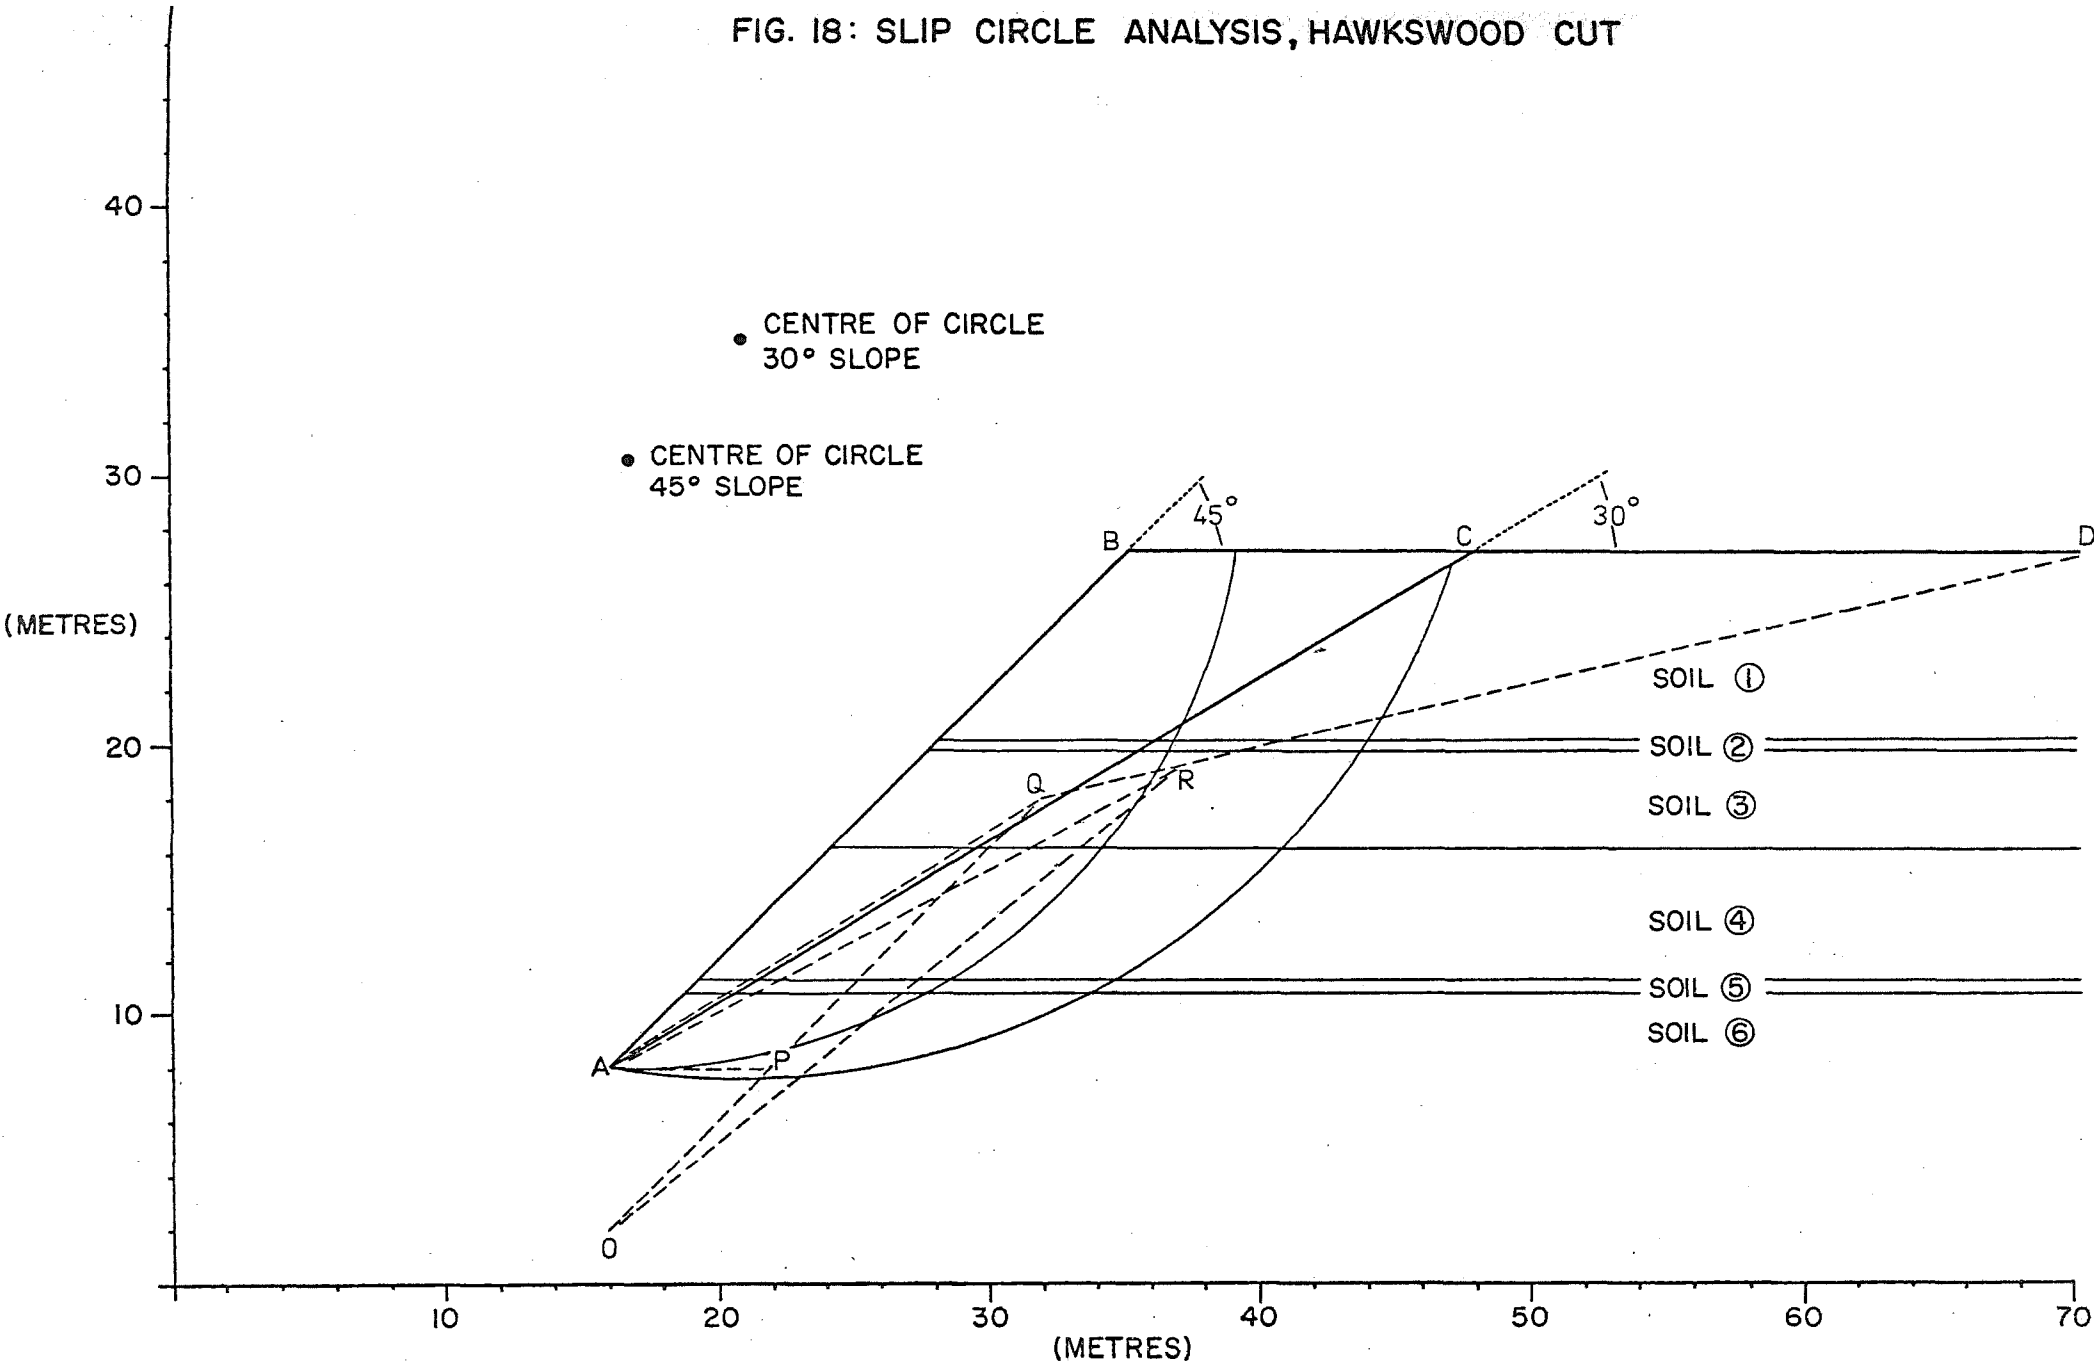
FIG. 18: SLIP CIRCLE ANALYSIS, HAWKSWOOD CUT

(a) A cross-section, with a slope angle of 45° from the horizontal, through a point 1200m along the western slope was used for the analysis (Line ABD, Fig. 18).

(d) A control was initiated so that only slip circles passing close to or through the batter toe were analysed. The phreatic surface was reduced in level (line AQD on Fig. 18) until a safety factor approaching 1.00 was attained.

(f) The slope angle was reduced to 30° at the same cross-section (line ACD, Fig. 18). Analyses of the same phreatic surfaces, adjusted for slope reduction, were performed (lines ARD, AORD, APRD).

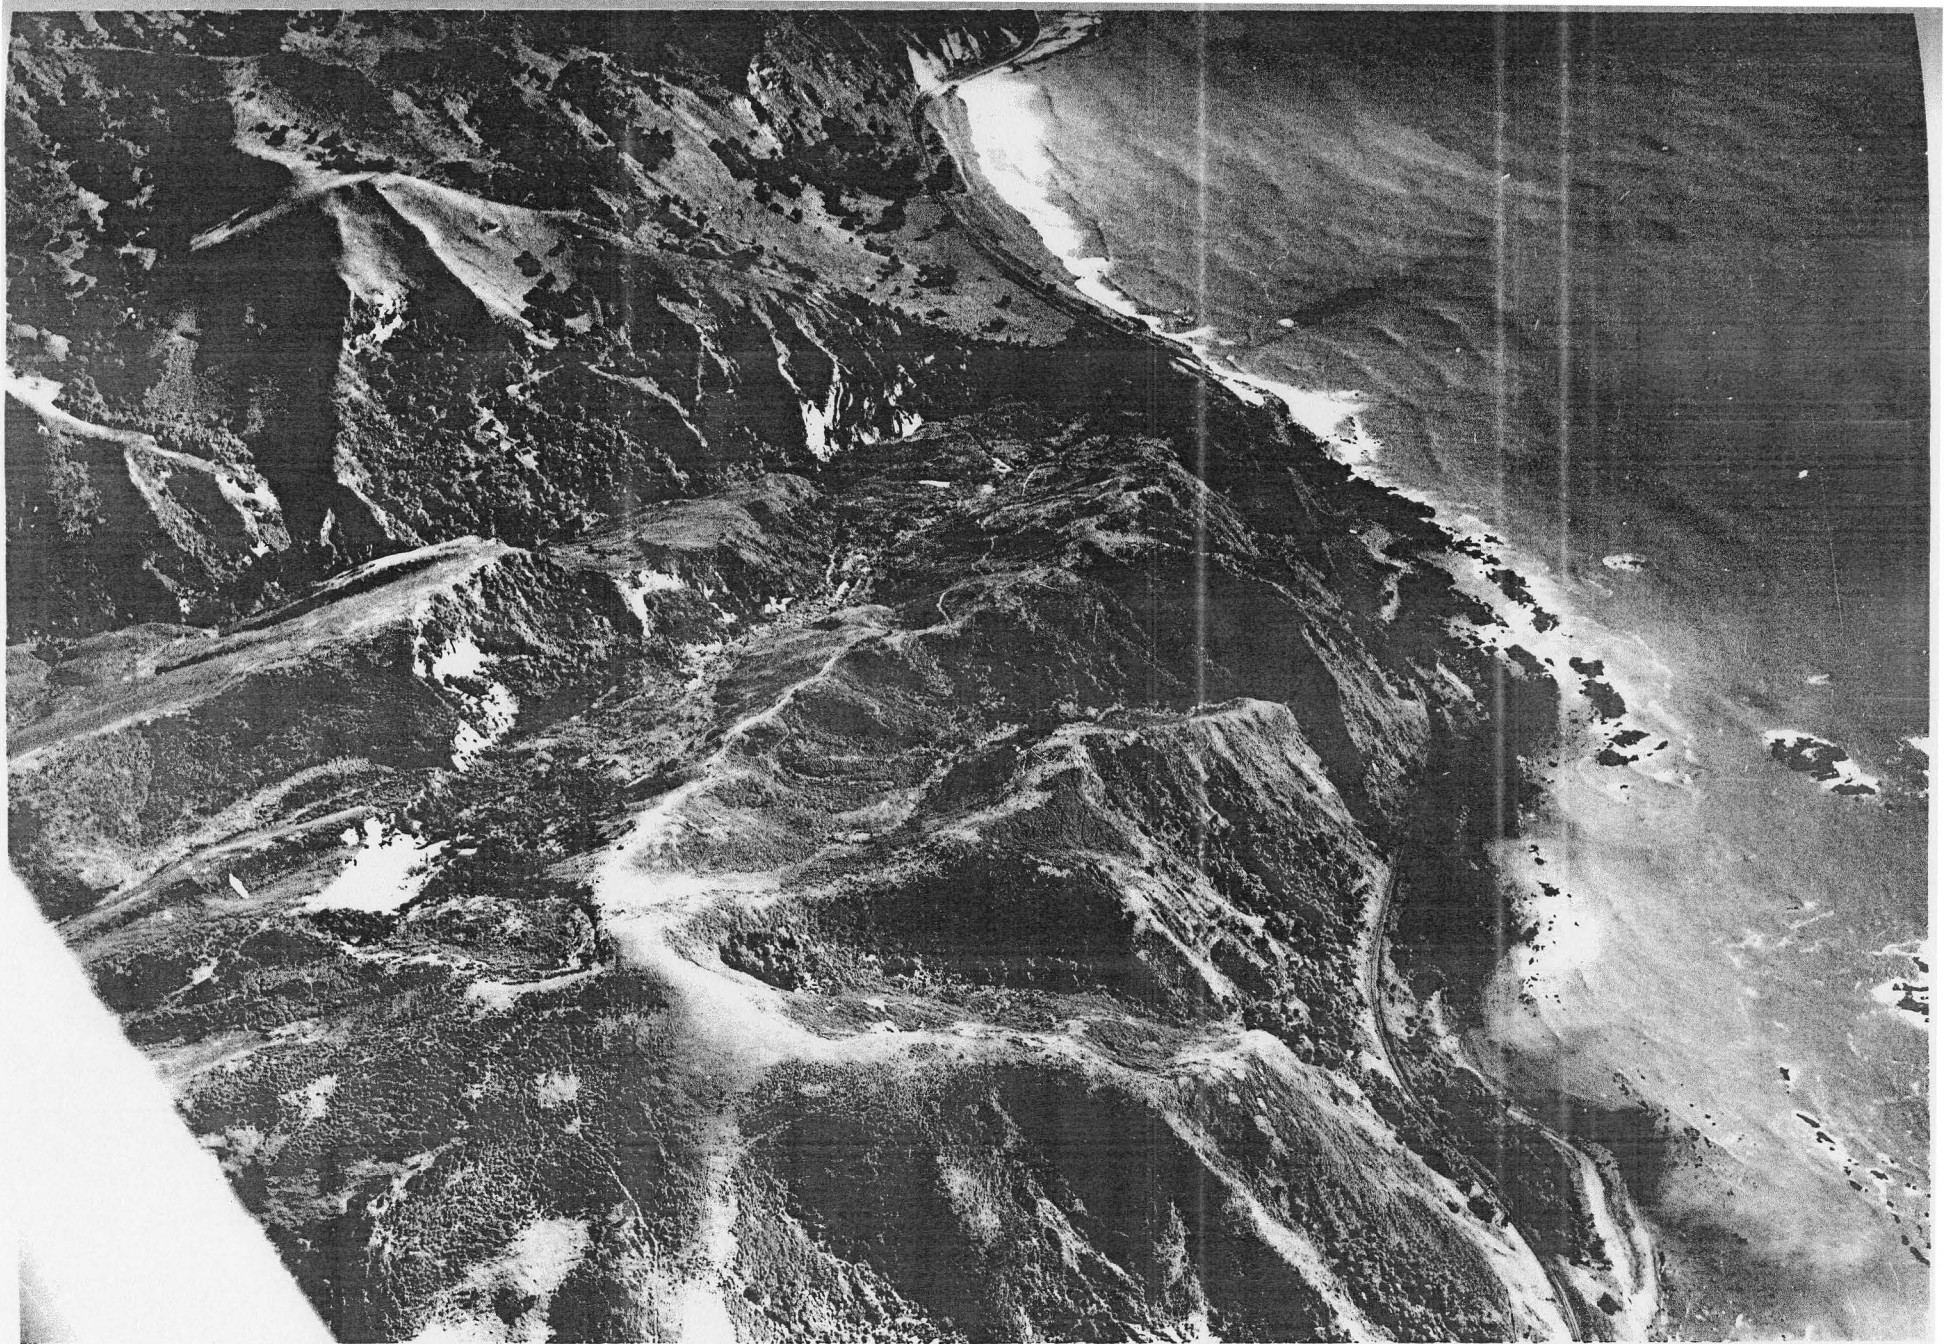
The general appearance of the earthflow, a long, narrow tail diverging downslope to a wide tongue, flanked by high, steep sided ridges on both margins, has similarities to a glacial ice flow (Plate 16). As well, movement in earthflows of the type at Mikonui by a slow, creeping, plastic flowage of soil particles forming the slide mass is generally thought to take place; such displacements also have analogies to glacial movements. The mechanics of

PLATE 16. The Mikonui earthflow, occupying the long, narrow depression in the centre of photograph.

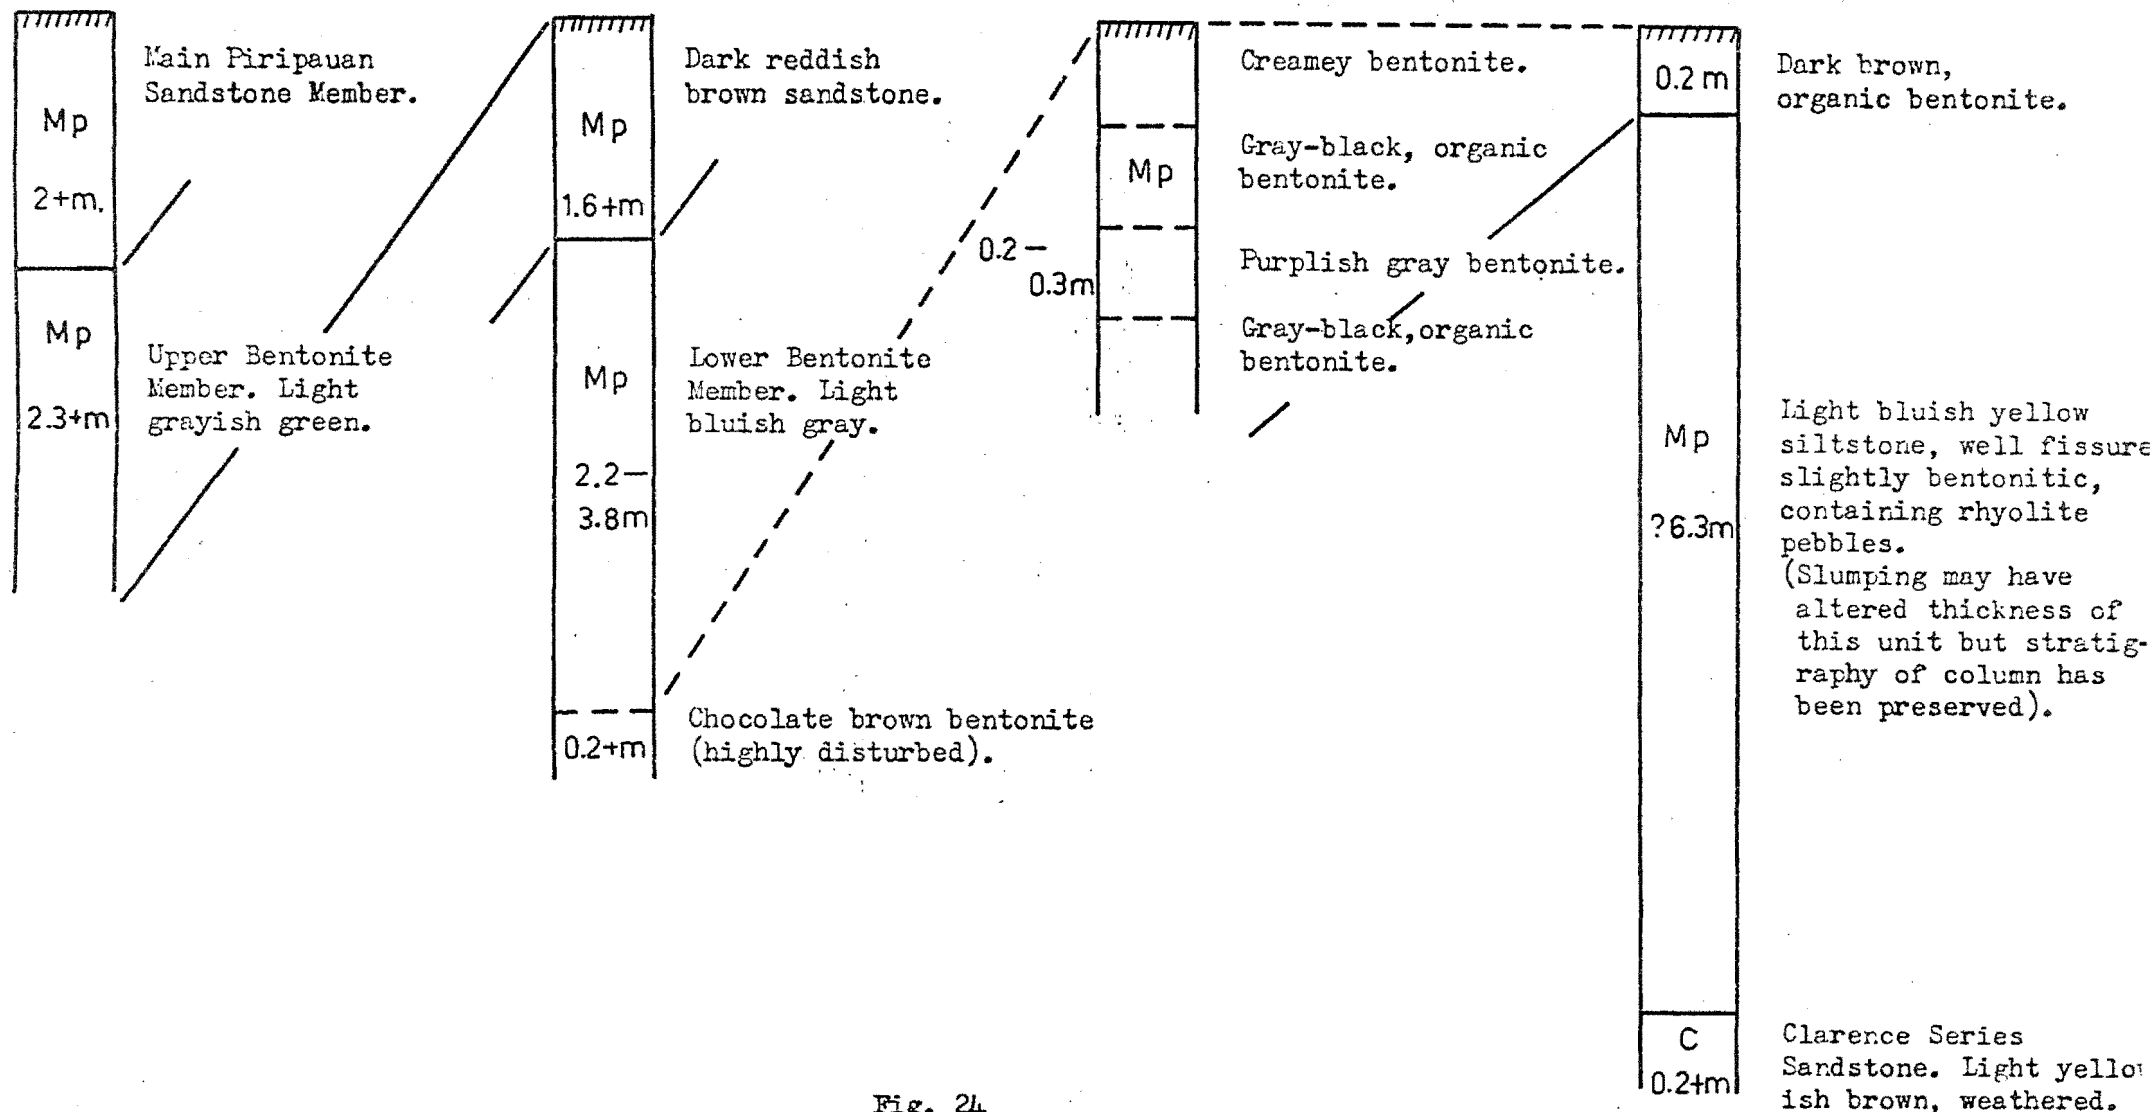
Fig. 24

Summary of critical Upper Cretaceous stratigraphy preserved at head of Mikonui Stream Tributary.
